CALSPAN ON-SITE AIR BAG DEPLOYMENT INVESTIGATION

CALSPAN CASE NO. 94-23

**VEHICLE #1 - 1993 CHEVROLET CORSICA LT (AIR BAG-EQUIPPED)
VEHICLE #2 - 1986 CHEVROLET CELEBRITY STATION WAGON**

**LOCATION - STATE OF MASSACHUSETTS
CRASH DATE - [REDACTED], 1994**

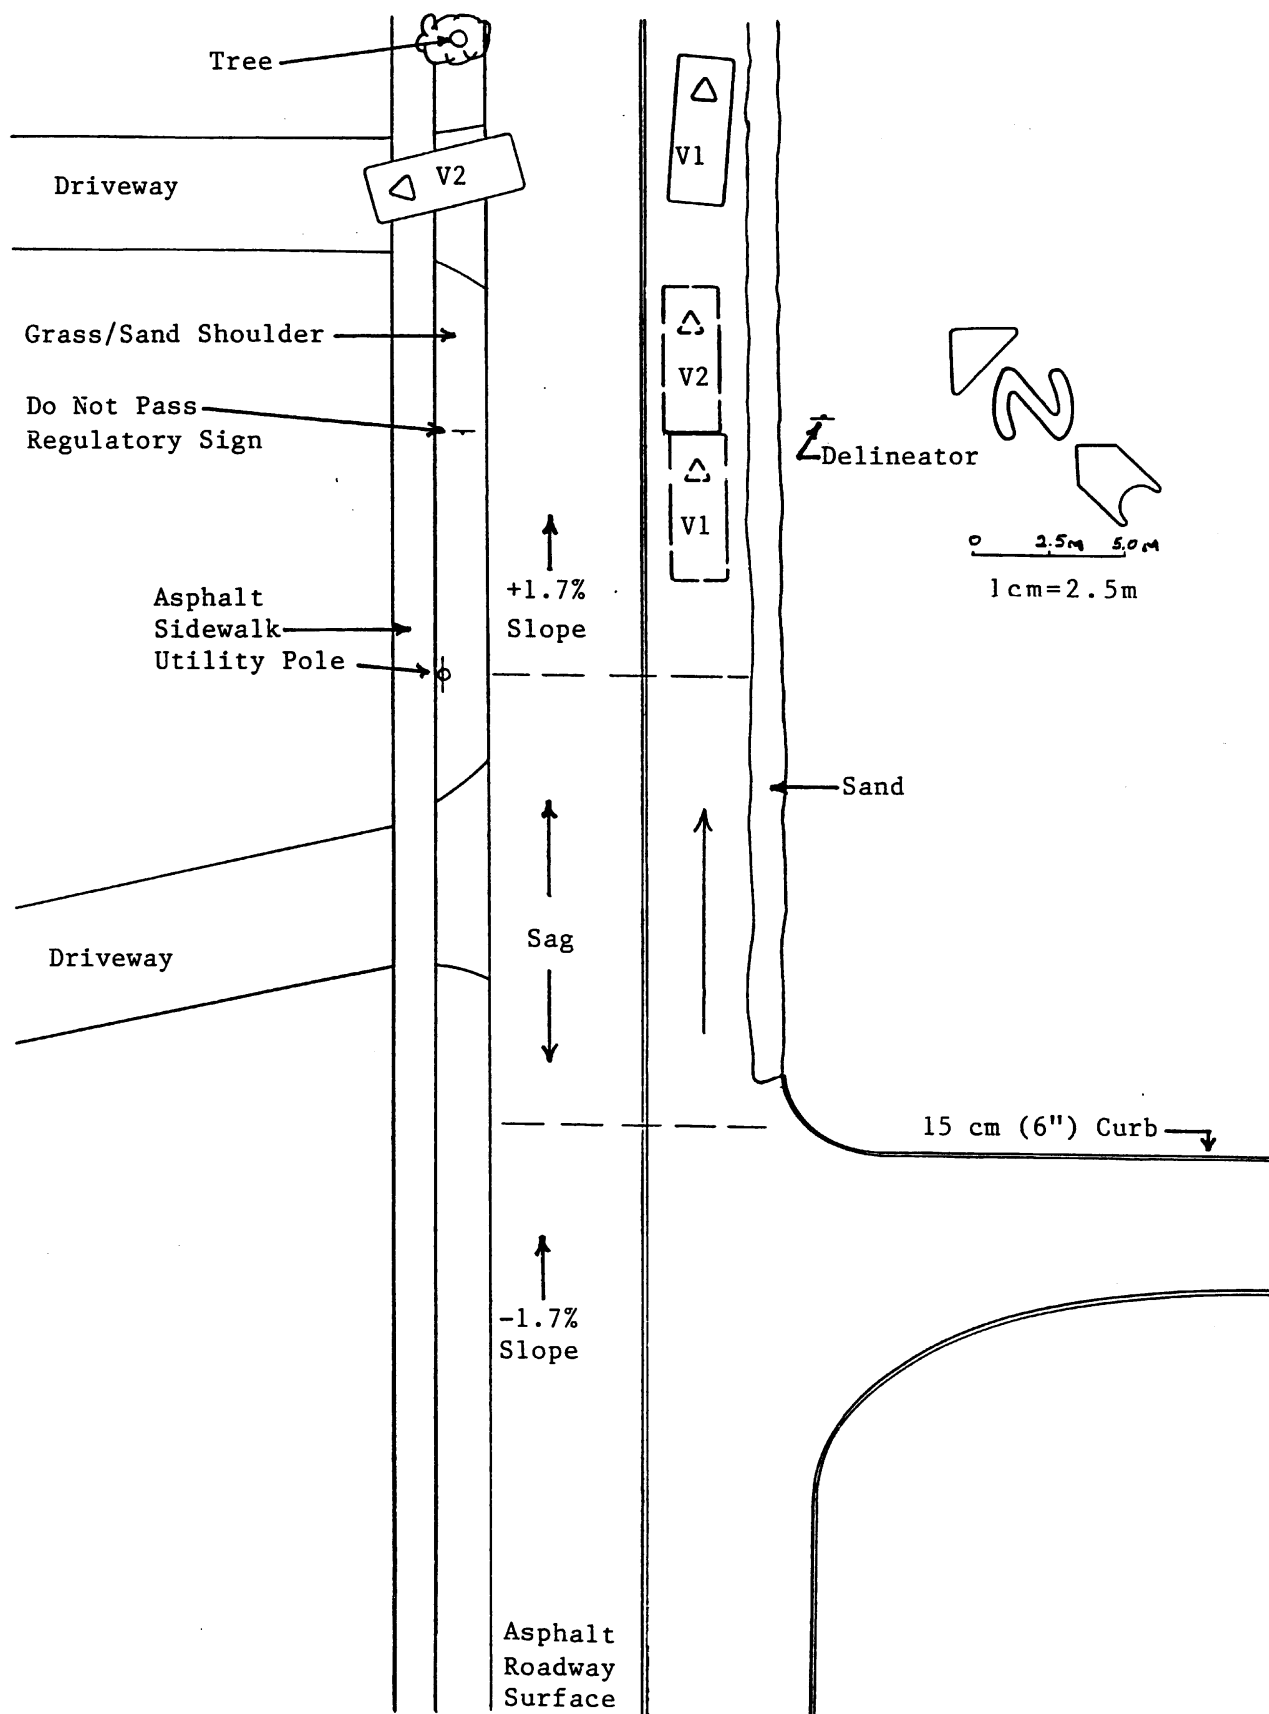
Crash Scene Schematic
Calspan Case No. 94-23

Vehicle #1 (1993 Chevrolet Corsica LT four door sedan) was traveling north on a two lane, undivided, straight, positive 1.7 percent slope, dry, asphalt roadway when it struck the rear of Vehicle #2 which was stopped in the northbound travel lane while yielding to a pedestrian pushing a baby carriage north along the west side sidewalk prior to attempting a left turn into her driveway. While yielding to the pedestrian's travel path, the front wheels of Vehicle #2 were turned to the left in anticipation of entering the driveway. The ambient condition at the time of the crash was sunny with no adverse weather conditions.

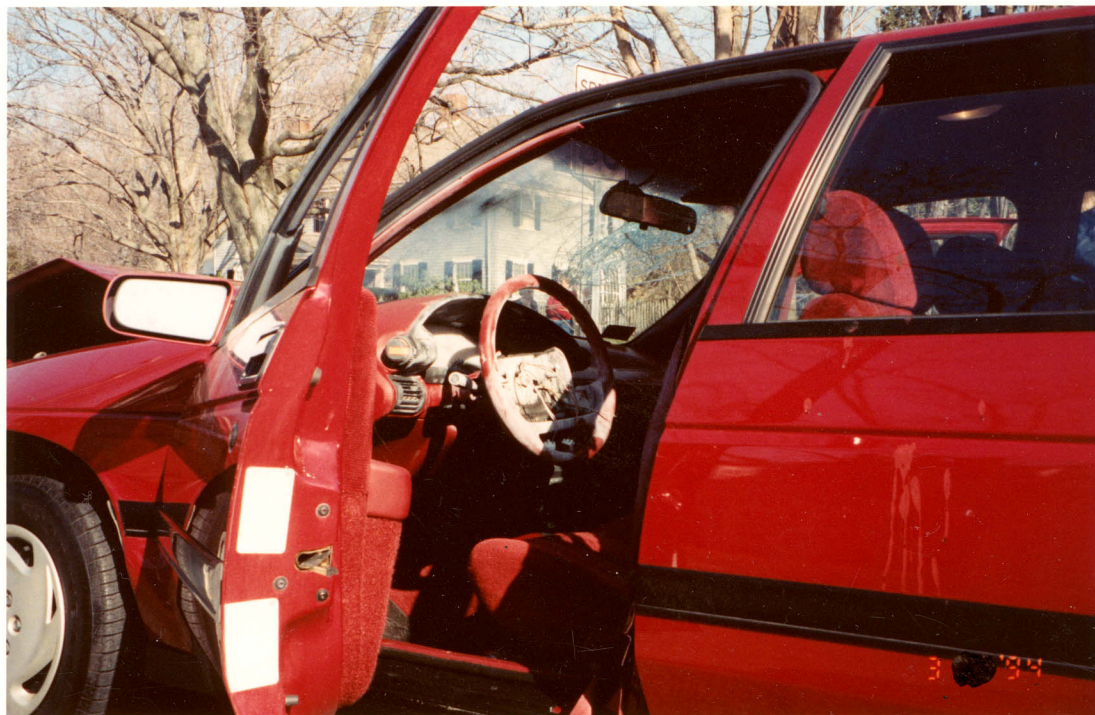
31. On-scene view of the steering wheel showing the separation of the air bag module from the steering wheel hub and a heavy generant residue.

The fracture site provided an abnormal release path for air bag gas generant which bypassed the inflator diffuser screens and allowed direct venting into the vehicle interior. The escaping gas applied a thrust to the rear of the air bag module which resulted in the separation of the module from the hold down clinch nuts located into the steering wheel hub. As the clinch nuts extruded through the module mounting plate, the module moved rearward toward the driver spewing hot gases and air bag gas propellants into the vehicle interior. This was evidenced by the concentration of dark dots associated with generant pellets on the inside of the windshield with the heaviest concentration located directly above the steering wheel (see photographs #20, #21 on pages A-10, A-11).

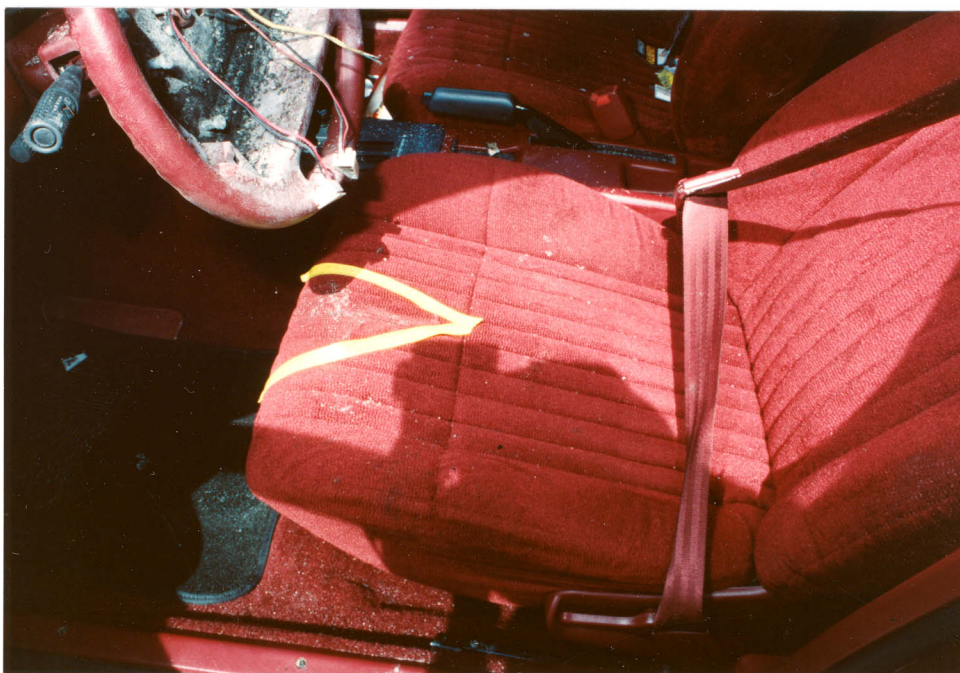
The driver's seat cushion exhibited a "V" shaped burn mark pattern which measured 10.2 cm (4.0") along the front edge of the cushion and extended rearward 17.8 cm (7.0"). This pattern occurred as air bag propellant dropped from the steering wheel area during the module separation and reflected the presence of the driver's legs which prevented a wider distribution of propellant debris on the seat cushion.

33. Lateral view of the driver's seat cushion highlighting a "V" shaped area on the seat fabric which was singed by air bag generant debris.

A "V" shaped pattern in the center of the driver's seat cushion along the leading edge of the seat and measuring 10.1 cm (4.1") laterally and 17.8 cm (7.0") longitudinally contained a concentration of BB size burn marks from discharged inflator generant. The floor mat just beneath the steering wheel exhibited a 1.9 cm (0.8") burn mark where the fibers were melted by generant pellets which dropped down from the steering wheel hub (refer to photographs #33, #35, #36 on pages A-17, A-18).

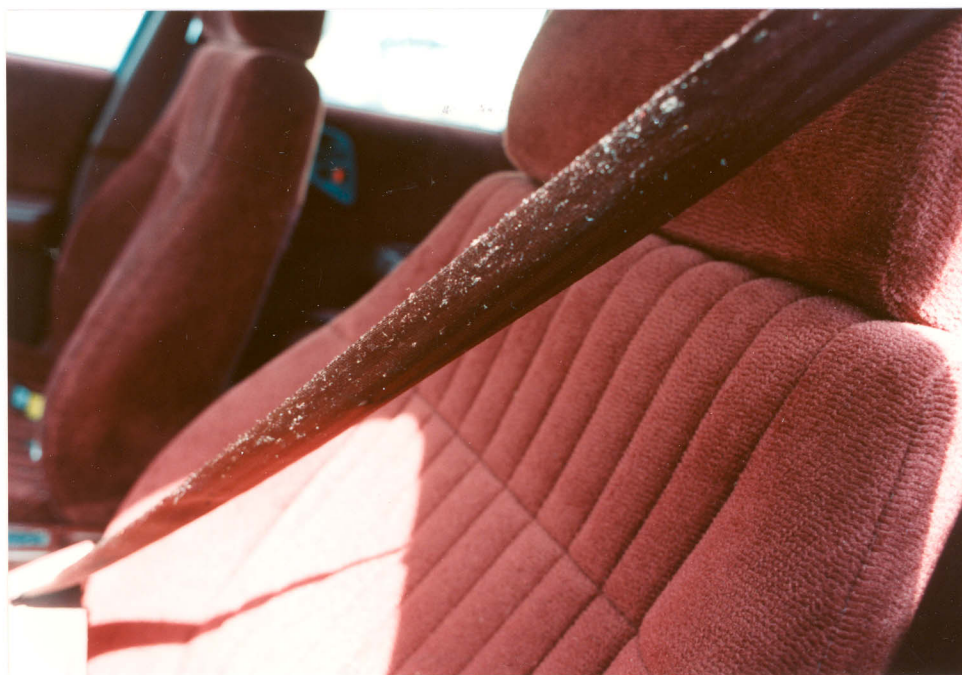
34. View of the driver's torso belt showing air bag generant debris embedded in the weave of the belt

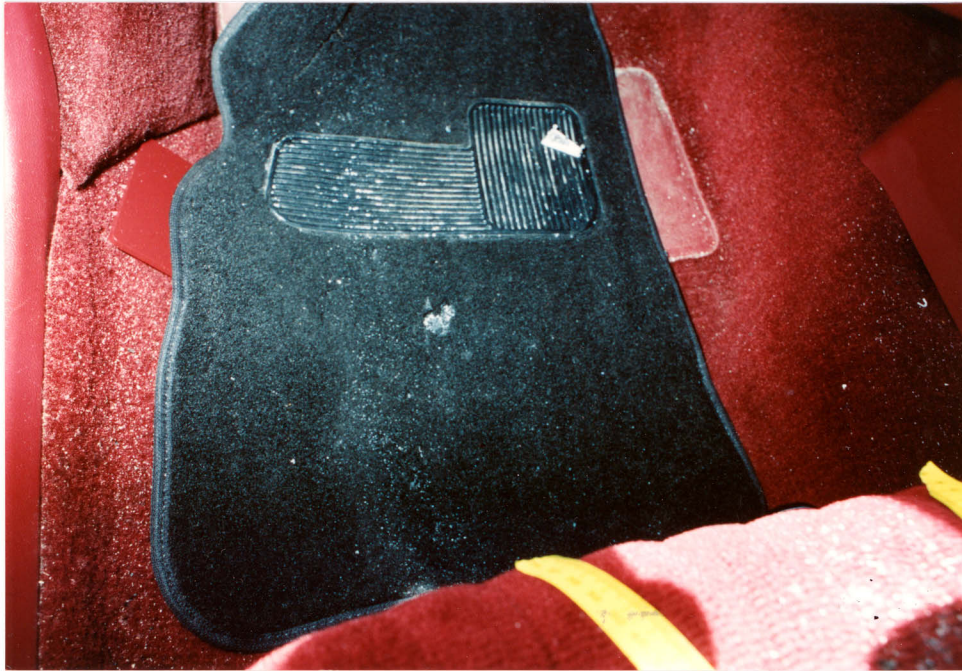
A 2.5 cm (1.0") diameter burn mark was noted on the driver's side floor mat directly below the steering wheel. This burn mark was the result of air bag propellant debris which fell from the recessed area in the steering wheel hub.

35. View of the driver side floor mat which was singed by air bag generant debris. This area was located directly under the steering column.

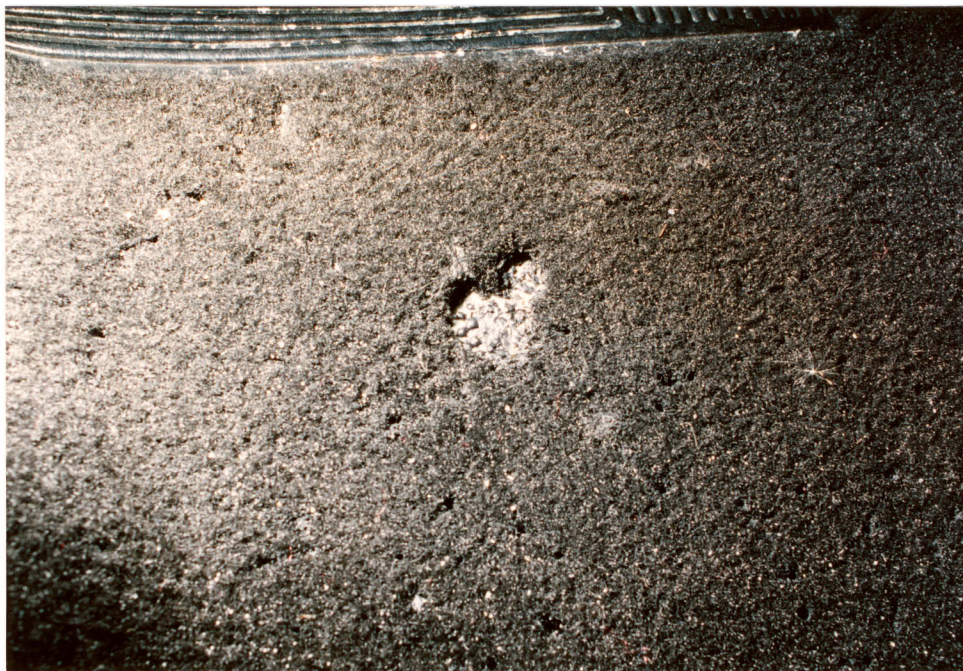
36. Close-up view of the singed mark on the driver side floor mat.

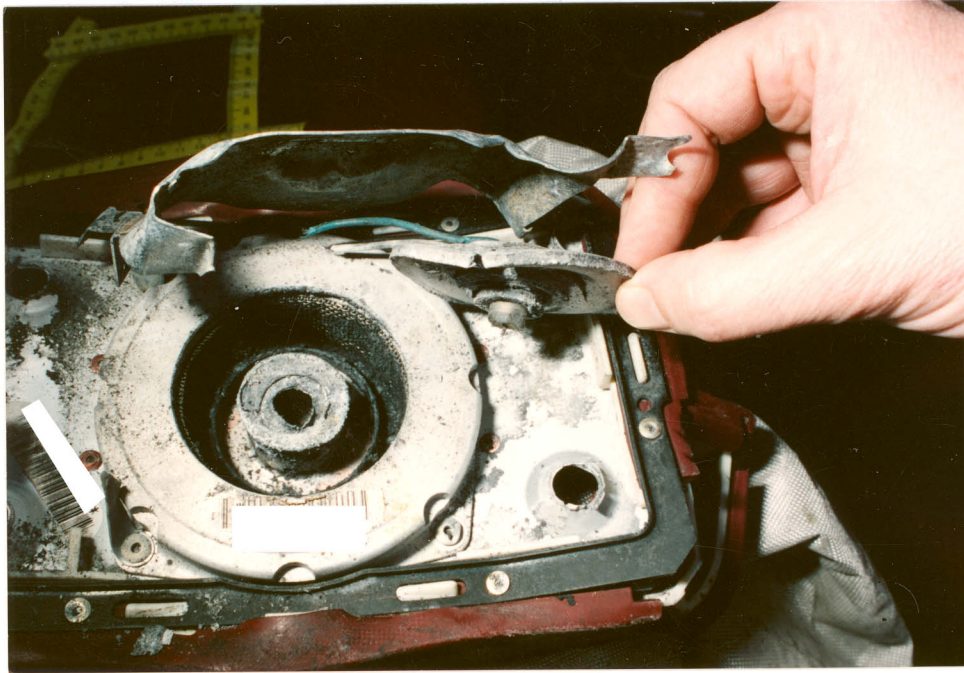
continued, the air bag inflator unit experienced a failure of the igniter weld land. This failure resulted in the bulging of inflator unit and the resulting fracture of the inflator base section (refer to photographs #47, #48 on page A-24).

47. Lateral view of the ignitor squib (Part #1) which was separated from the base of the inflator during the deployment sequence.

During the bulging event, the base surface of the inflator fractured and released sodium azide pellets and inflation gases into the vehicle interior (refer to photographs #46 - 48 on pages A-23, A-24). The air bag module pulled free from the attaching clinch nuts located in the steering wheel hub and landed on the center console between the front bucket seats (refer to photographs #37, #38 on page A-19). A concentration of dark dots associated with generant pellets was noted on the inside of the windshield with the heaviest concentration noted directly above the steering wheel (see photographs #20, #21 on pages A-10, A-11). The left front door panel was singed by air bag exhaust gas in an area measuring 27.9 cm (11.0") horizontally that began 29.2 cm (11.5") rear of the instrument panel and 17.8 cm (7.0") vertically down from the window sill (refer to photographs #63 - #65 on pages A-32, A-33).

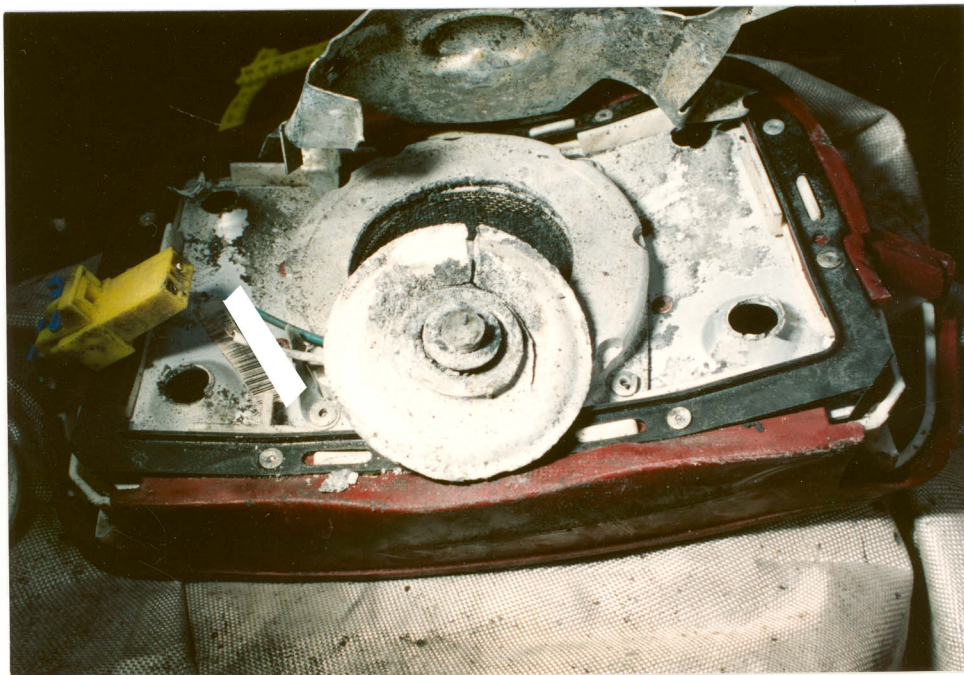
48. Reverse side of Part #1.

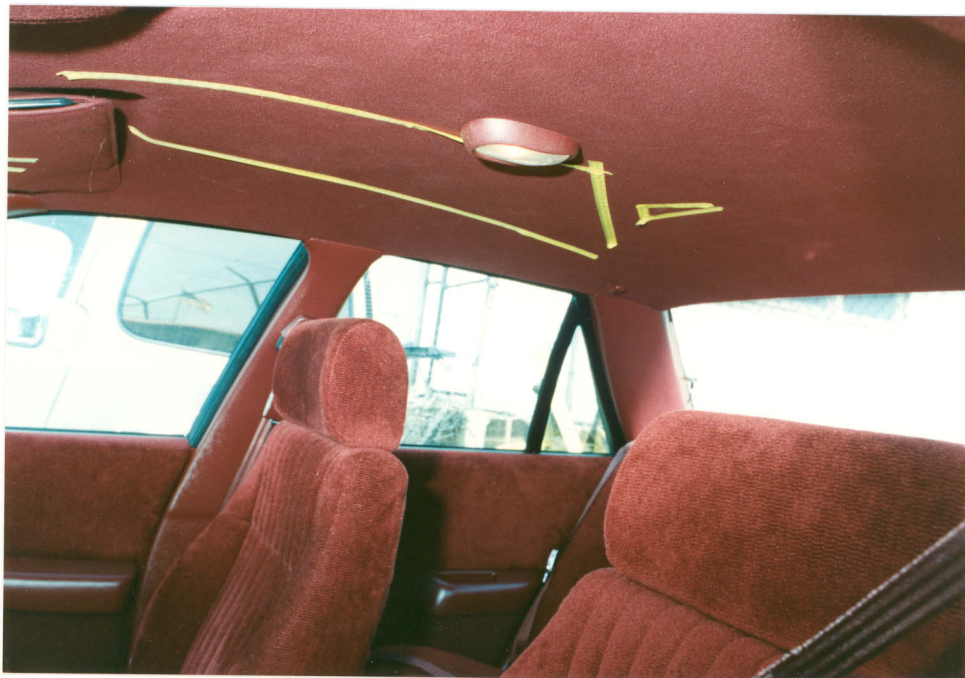
Black burn marks the size of BBs were noted to in the roof liner which began near the windshield header in the center of the vehicle and extended 99 cm (39") rearward into the right rear seat area. The pattern was 22.9 cm (9.0") wide near the windshield header and widened to 30.5 cm (12.0") in the right rear seat area.

50. View from the right side of the vehicle of air bag generant debris embedded in the roof fabric which began in the center of the vehicle and extended rearward to the right rear passenger area.

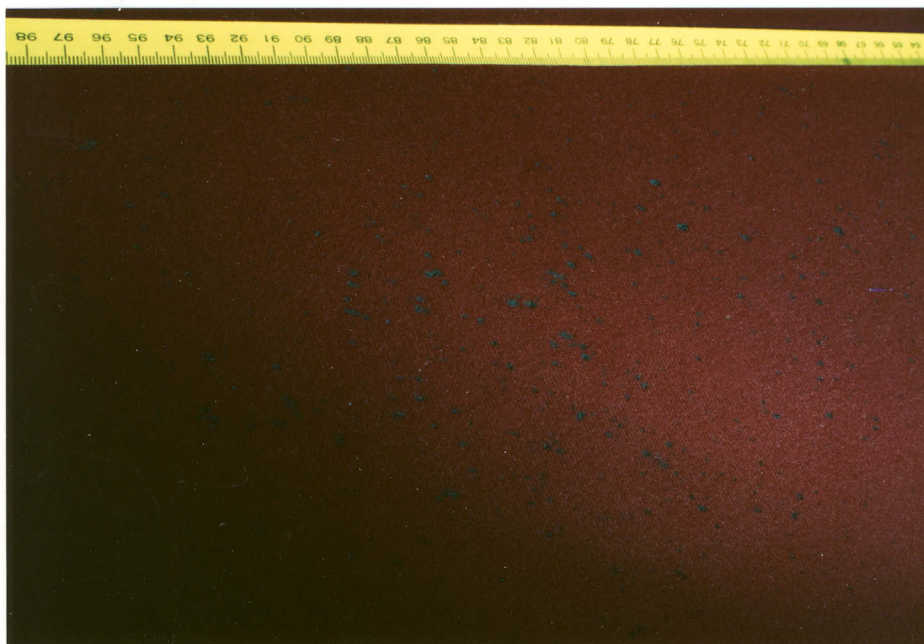
51. Close-up view of BB size burn marks from air bag generant debris embedded in roof fabric along the right side.

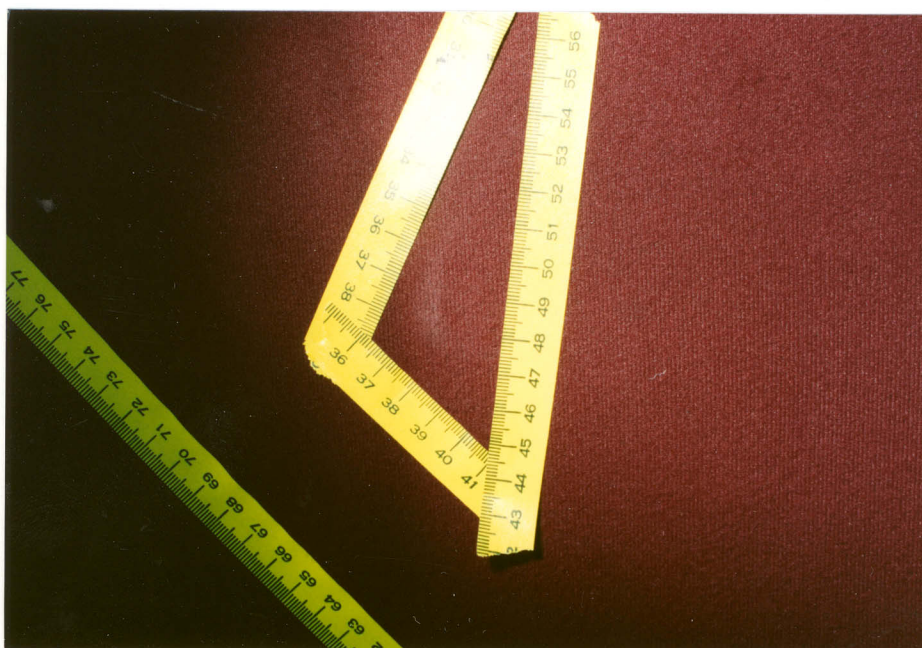
52. A light color transfer mark on the roof fabric over the right rear seat area,

The right rear lower area of the right front head rest exhibited a 12.7 cm x 5.0 cm (5.0" x 2.0") light colored bodily fluid transfer mark which was attributed to contact by the face of the right rear occupant. A 3.8 cm (1.5") light color transfer mark was noted on the roof fabric which was located 96.5 cm (38.0") rearward of the windshield header and 12.7 cm (5.0") right of the vehicle centerline (refer to photograph #52 on page A-26). This was attributed to contact by the right rear occupant.

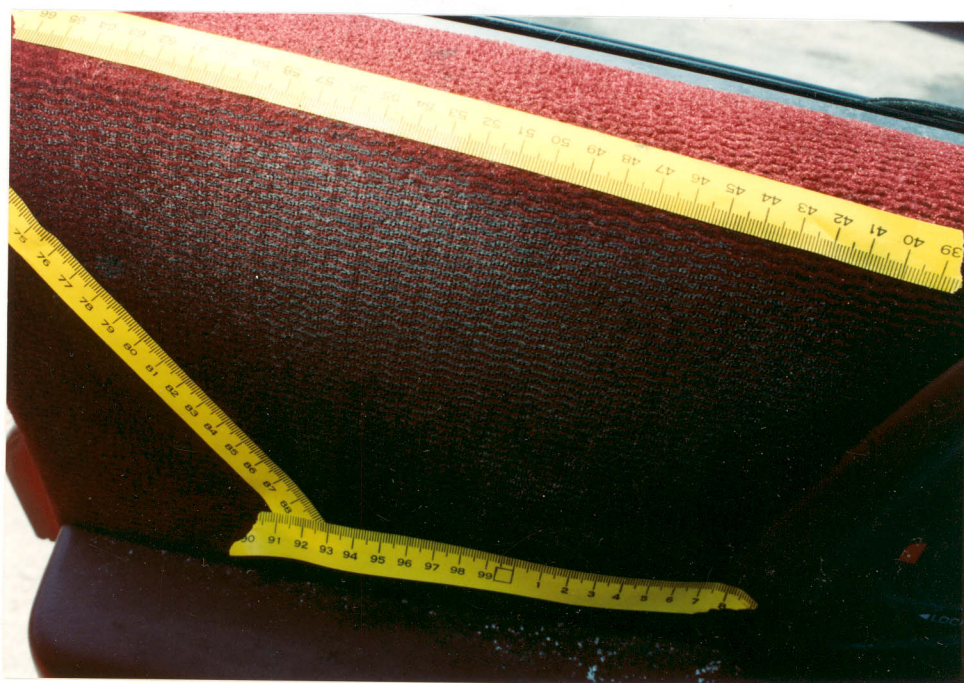
65. Close-up view of the singed fabric above the left front door armrest from air bag exhaust gases.

Burn marks in the driver's door side panel below the door arm rest resembled the size of BB shot and were associated with discharged sodium azide pellets (refer to photograph #66 on page A-33). This area was located 10.2 cm (4.0") rear of the instrument panel and extended 15.2 cm (6.0") along the horizontal surface.

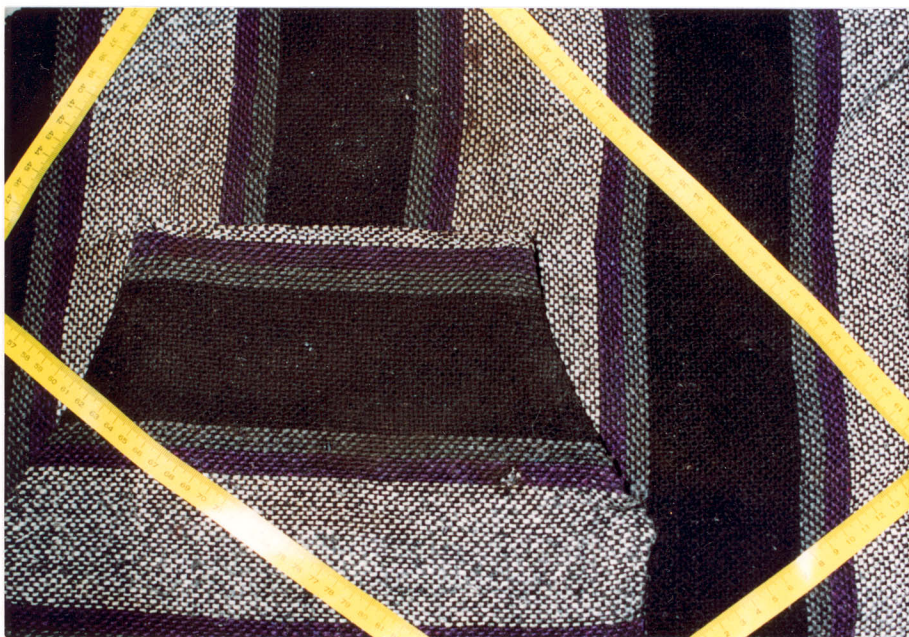
74. Closer view of the singed areas of the driver's pullover shirt.

It appeared the air bag module continued to move toward the driver with the bottom area rotating upward and the left side moving toward the in-board side of the vehicle, exposing the driver and interior components to gases which were exiting the fractured base section of the inflator unit. This movement resulting in the singeing of the driver's clothes (primarily his pullover shirt), his eyebrow, facial and head hair, and the driver's door surface.

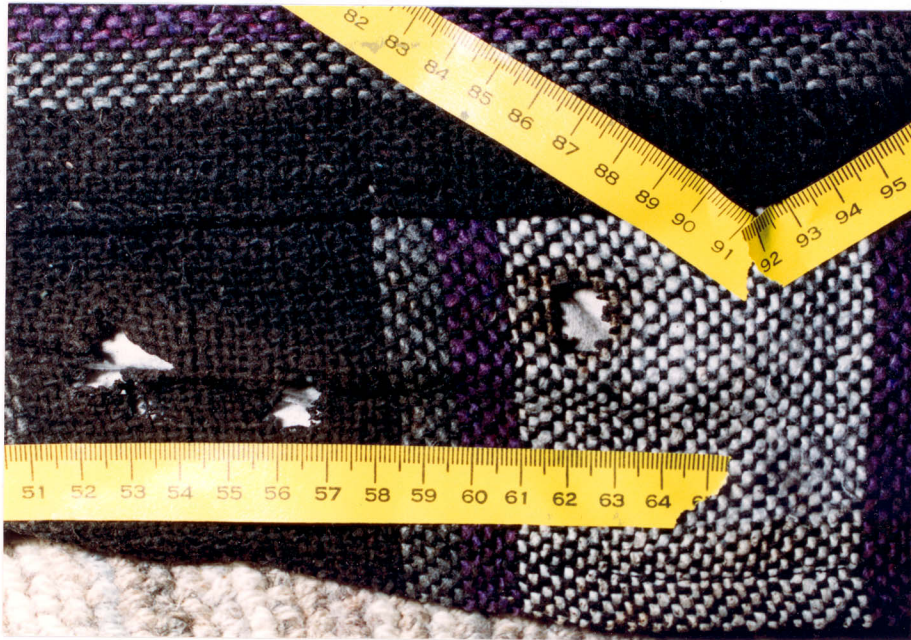
77. Close-up view of the lower portion of the pullover shirt fabric illustrating burn holes from air bag generant debris.

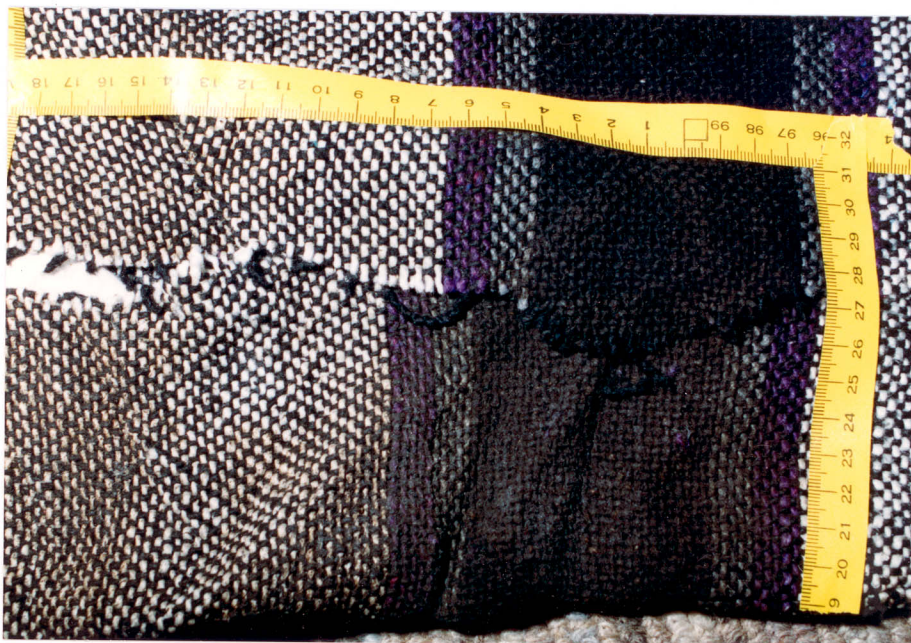
78. Close-up view of the left arm fabric illustrating discoloration from air bag exhaust gases.

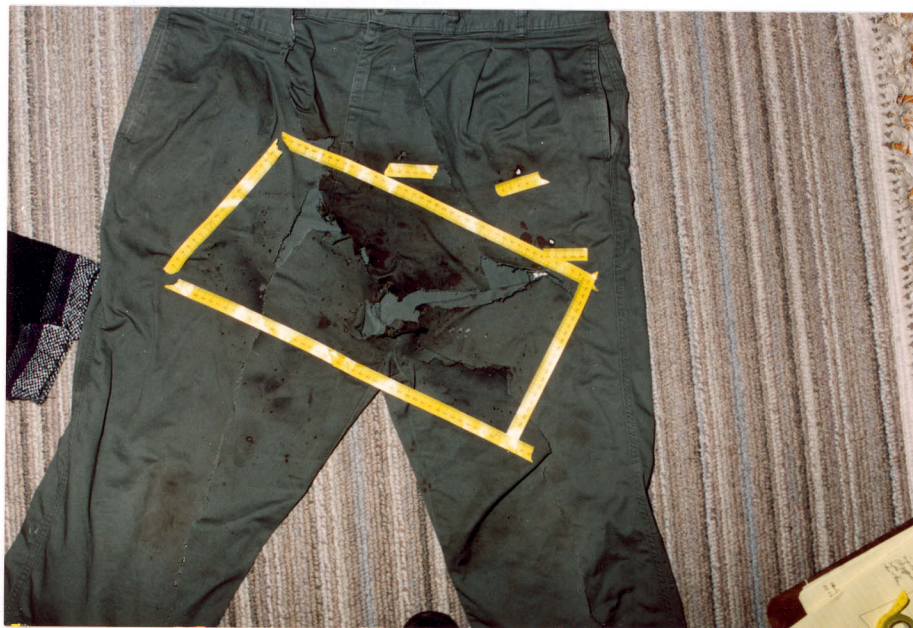
The driver indicated he noticed red embers falling from the steering wheel hub which landed on his lap. An examination of the driver's cotton pants and lower portion of the his pullover shirt revealed several burn holes which several were of BB size. Three large holes were noted above the crouch area in the pants and left of the zipper in which two holes measured 1.3 cm (0.5") in diameter and the third measured 0.48 cm (0.19") in diameter. These holes exhibited a surrounding dark ring burn pattern (refer to photographs #79, #80 on page A-40).

79. View of the driver's pants showing burn holes and heat discoloration of the fabric. Rips in the fabric were the result of on-scene medical rescue procedures.

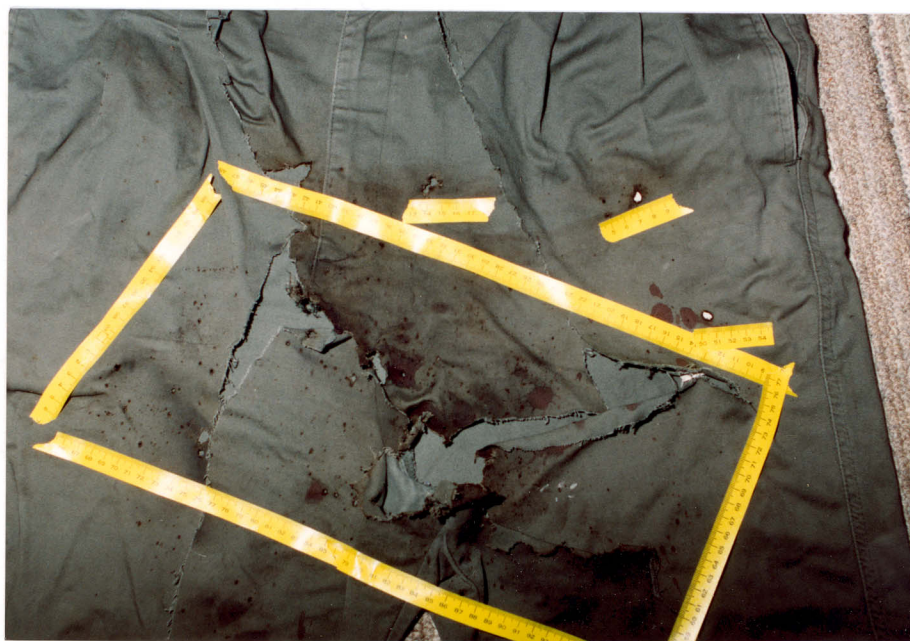
80. Close-up view of burn marks in driver's pants.

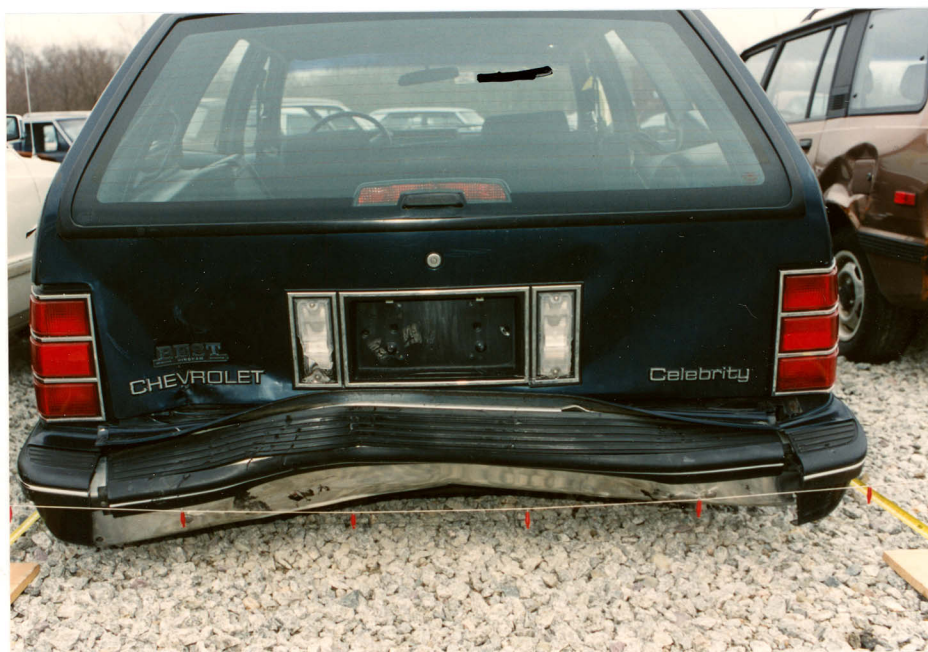
83. Left rear corner view of Vehicle #2 showing impact damage.

Exterior damaged components to this vehicle included the rear bumper, tailgate, backup lights, roof structure, and both rear doors. The top portion of both rear door window frames were displaced outward by the deformation of the vehicle's roof. The bumper was deflected downward 29.2 cm (11.5") resulting in an incremental vertical shift value of 40. The rear tires were restricted by the side fender panels that were displaced forward by the impact (refer to photograph #92 on page A-46).

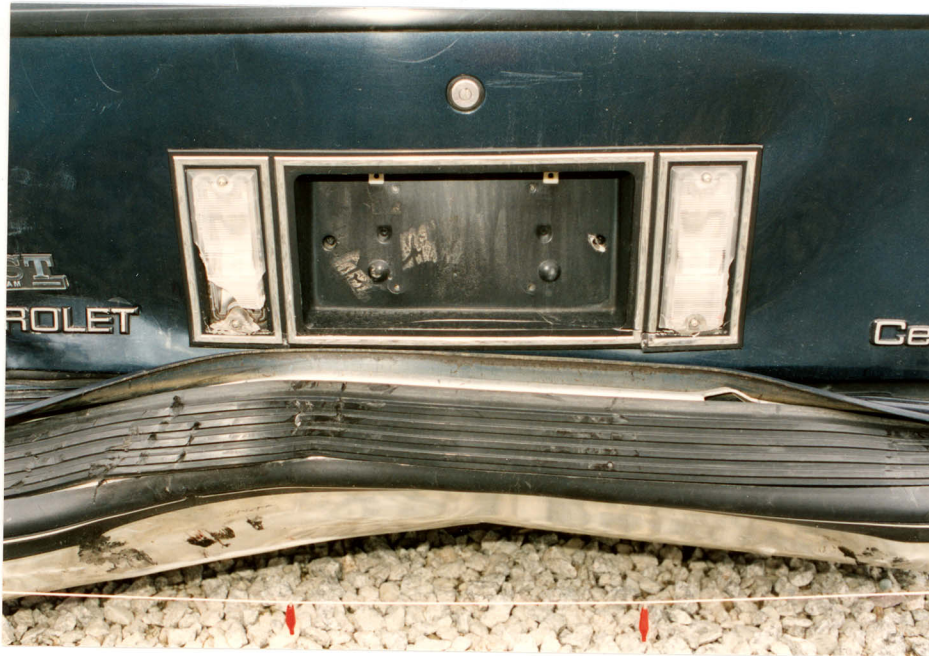
87. View of the center third of the rear plane showing direct contact damage.

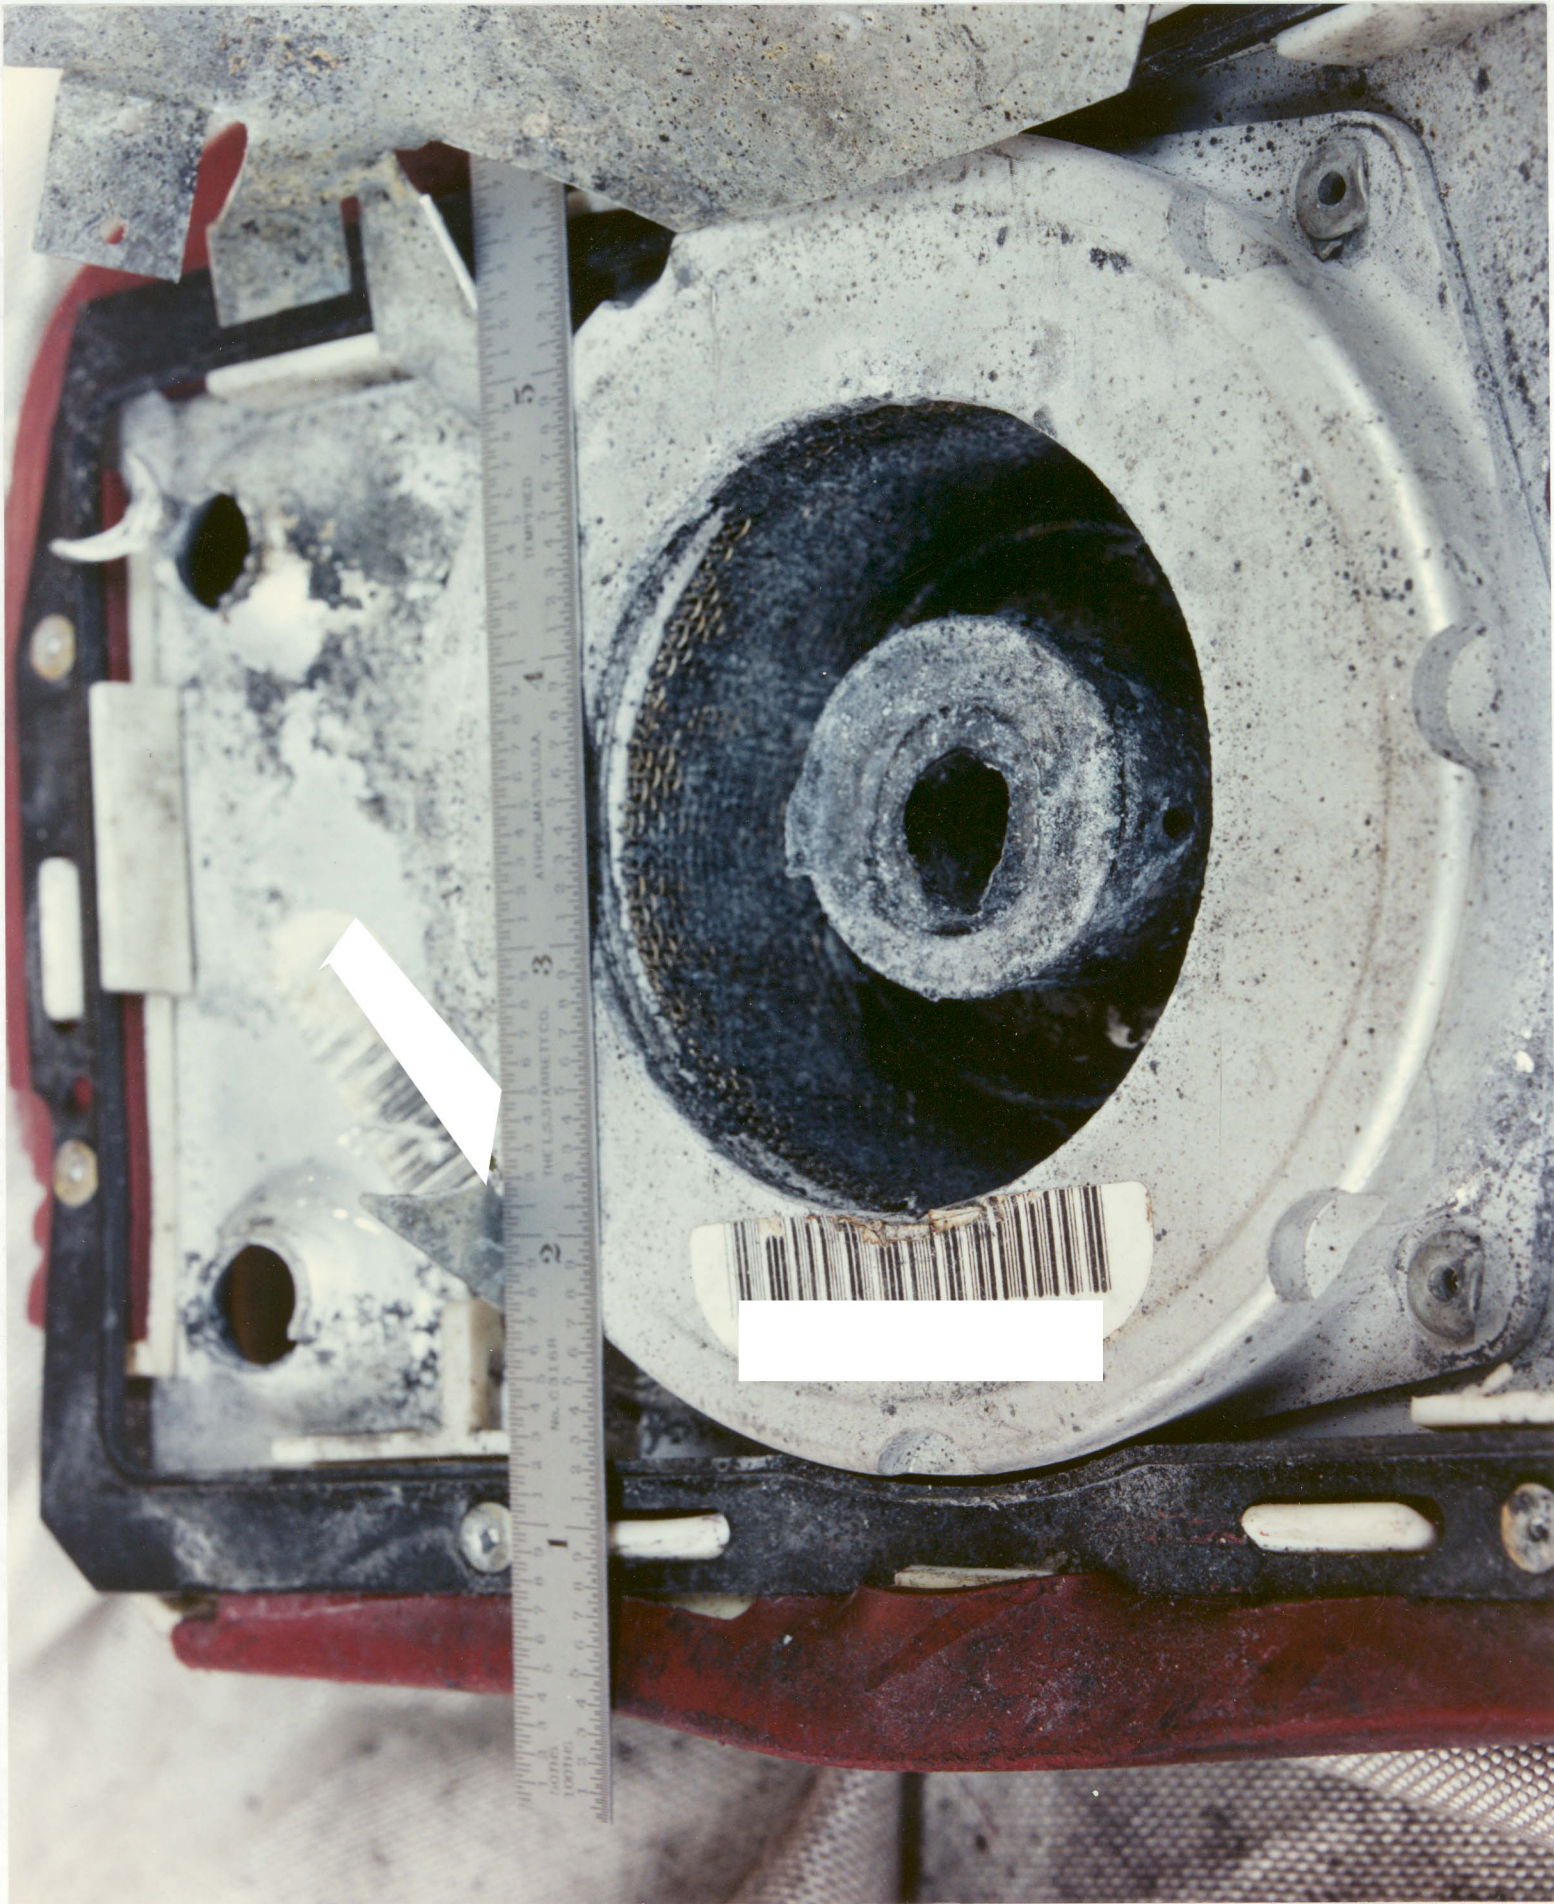
99. View of the inflator taken from the left side of the unit. Note the weld shear lip on the igniter can.

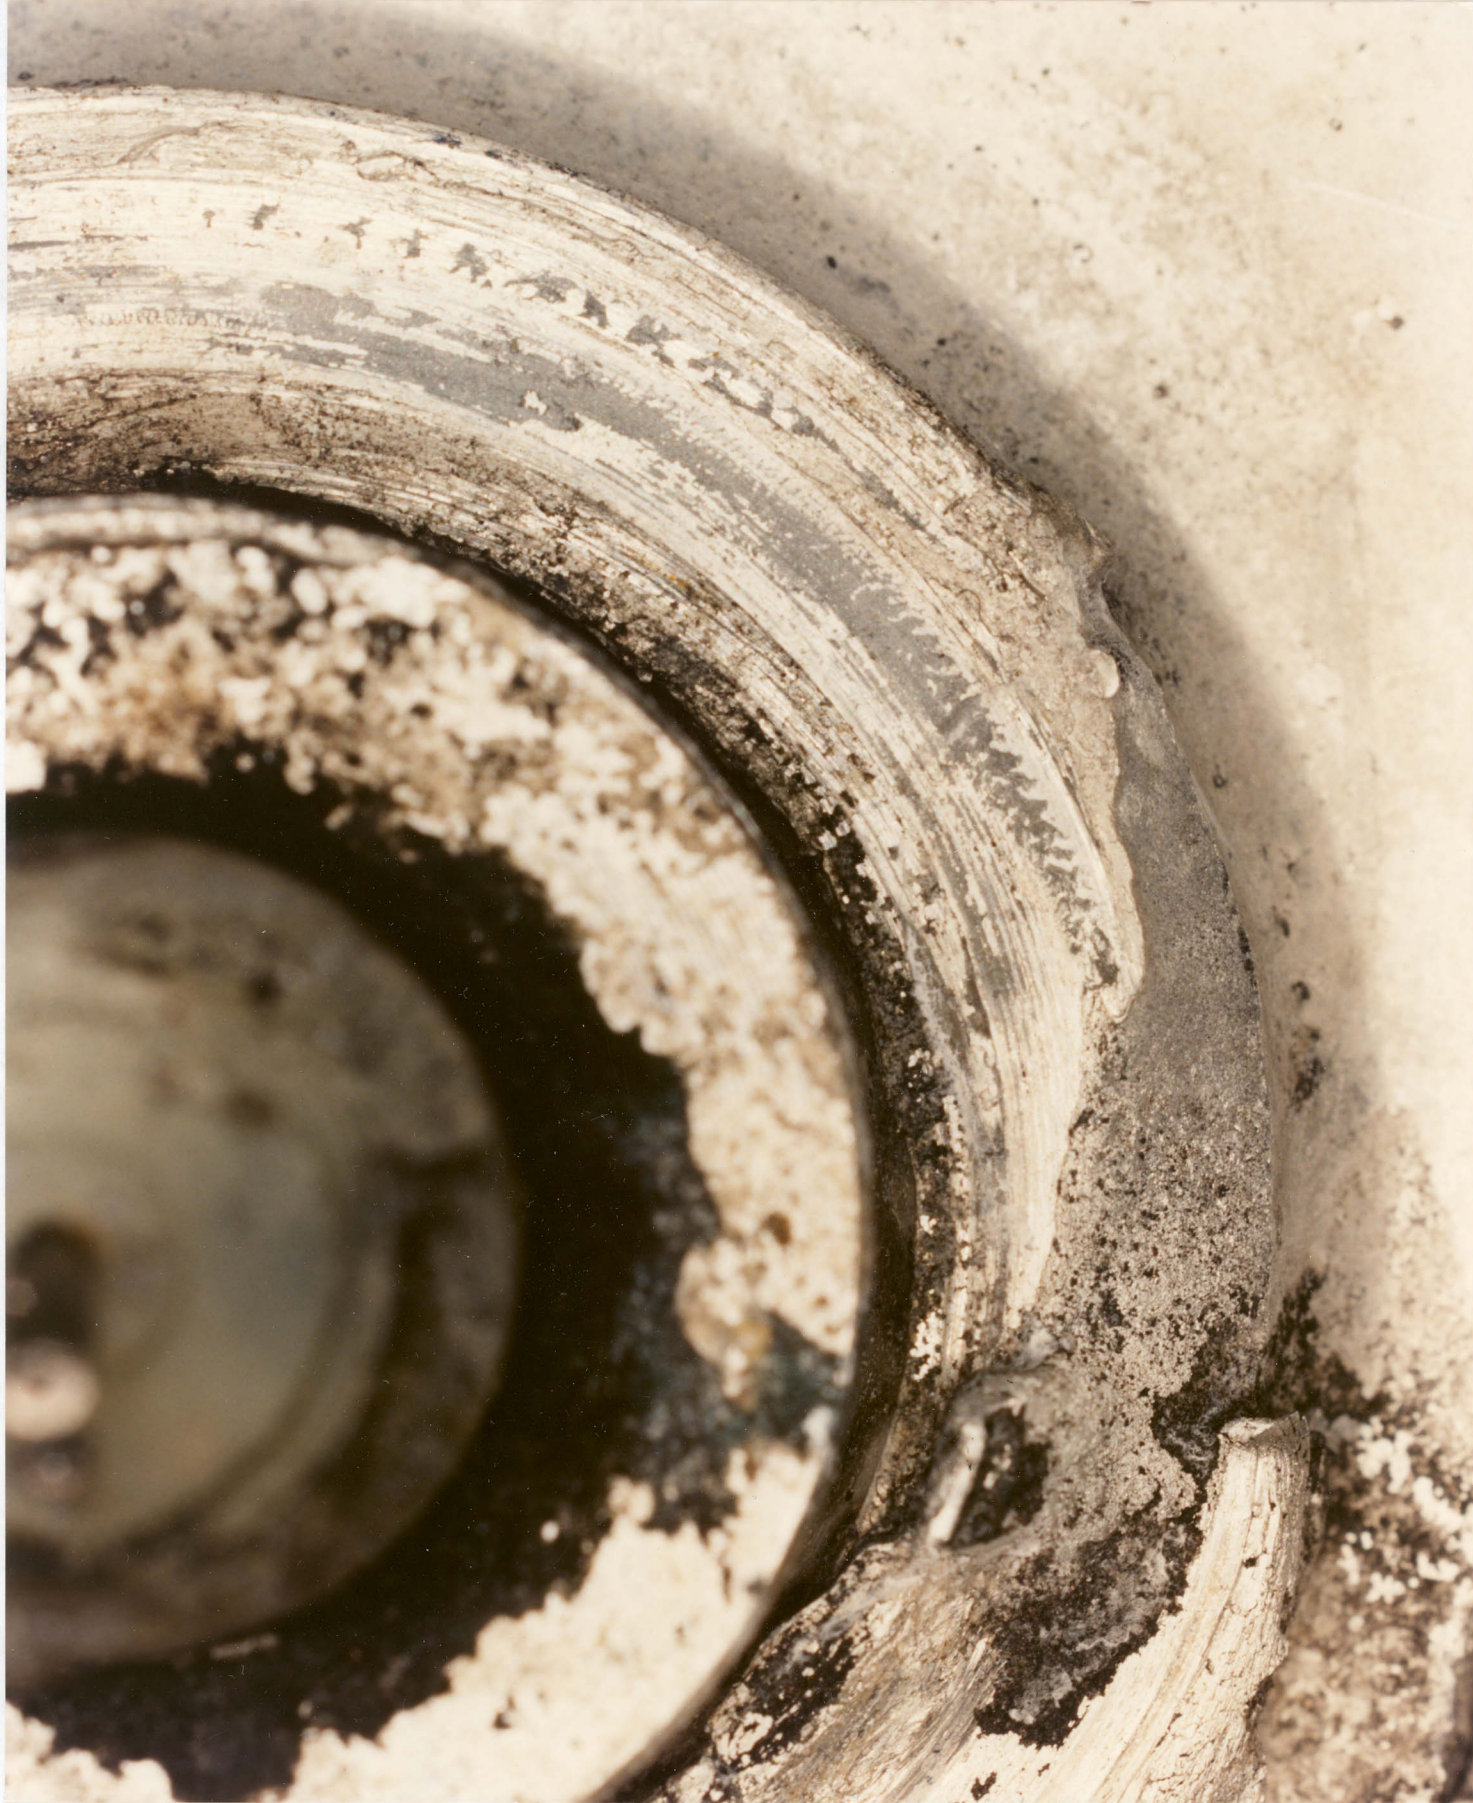
101. Close-up view of the defective weld on the igniter weld land of the fractured squib section which is visible at the uneven surface (i.e. dark gray area).
